# UNITEC

Assembly instruction-01 Rev.07\_en

## Installation procedure

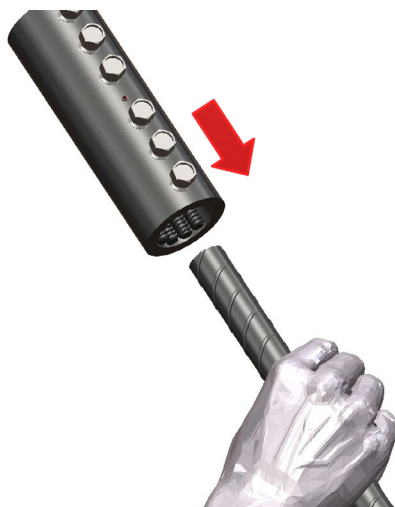
01

Place the Unitec coupler over the end of the first bar until the bar hits the center pin inside the coupler.

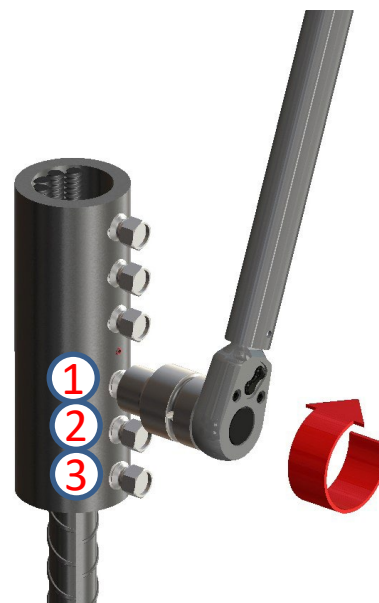
02

Pre-tighten the bolts with a manual wrench from centre to edge (1 to 3) of the coupler to pre-position the bar progressively and maintain its alignment inside the coupler.

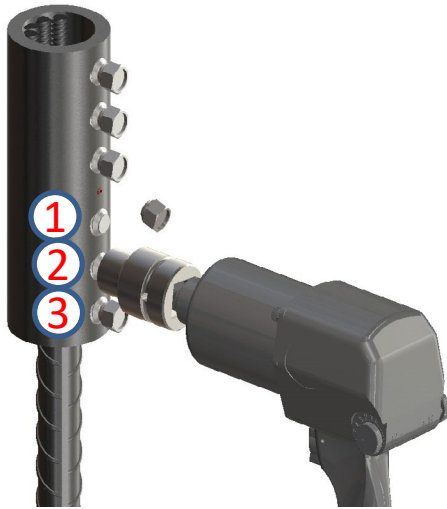
04

Tighten the bolts from centre to edge (from 1 to 3) with an impact wrench in several steps until the heads of the bolts shear off.

**Remark:** A manual wrench can be sufficient when only a small amount of couplers needs to be tightened.

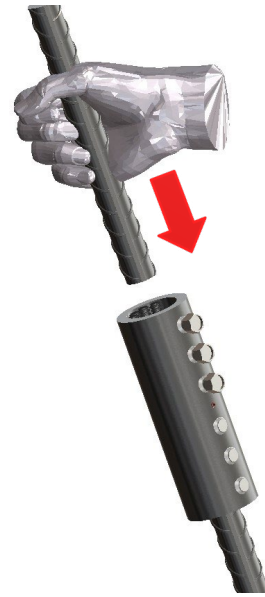
05

Insert the continuation bar on the other side of the Unitec coupler until it is in contact with the centre pin inside the coupler.

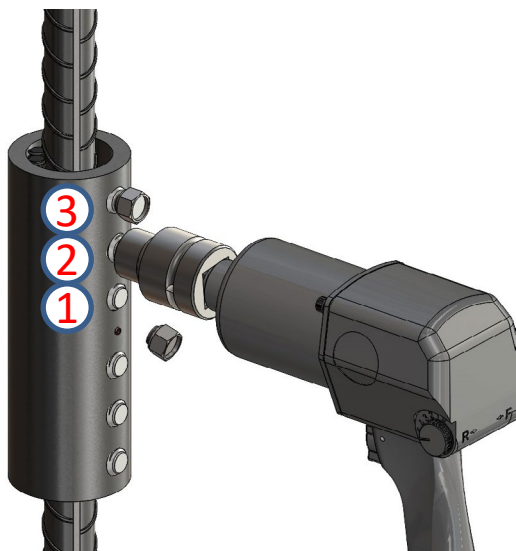
08

Tighten the bolts from centre to edge (from 1 to 3) with an impact wrench in several steps until the heads of the bolts shear off.

**Remark:** A manual wrench can be sufficient when only a small amount of couplers needs to be tightened.

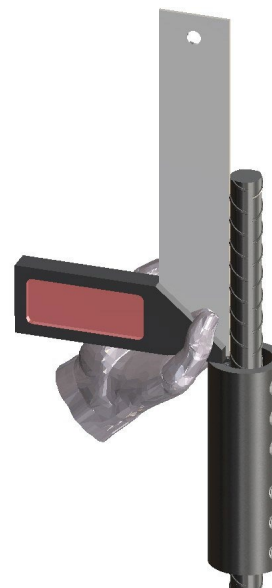
09

Ensure proper alignment of the bar at a distance of 25 cm. The misalignment should not exceed 5 mm (or not more than 1/4" at a distance of 1ft.).

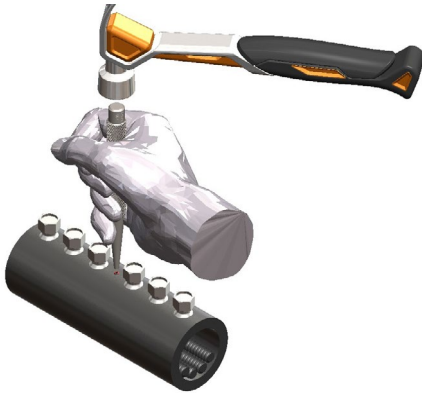
01

Remove the center pin with a punch.

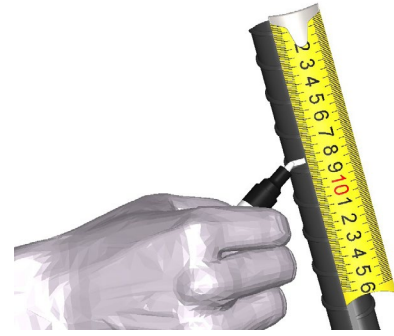
02

Mark the bar engagement length on each bar end, using the data provided in the table below.

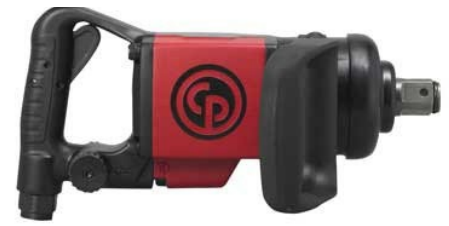
Either pneumatic impact wrench or electric impact wrench can be applied. The recommended pneumatic impact wrenches and electric impact are listed below. Other brands/model with specification equivalent to those indicated in the list can also be used and the tensile performance of Unitec splices should be determined before starting the job.

Unless an impact wrench is available, a hand wrench can be used instead.

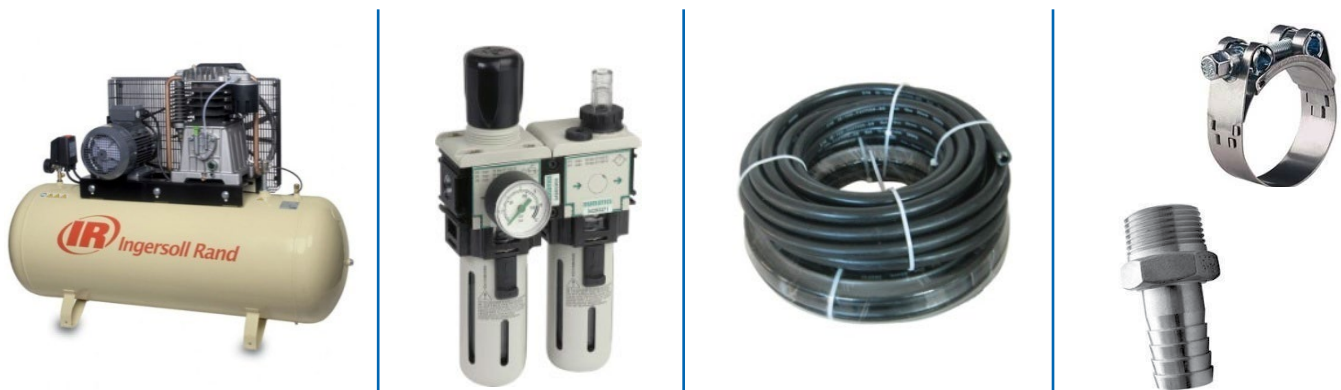
The requirement for air flow is 100 psig (7 bar) of operating pressure and 70 cfm (2m3/min) of delivered air to the pneumatic impact wrench through a ¾" (Unitec 12 to 25) or 1" (Unitec 12 to 50) hose.

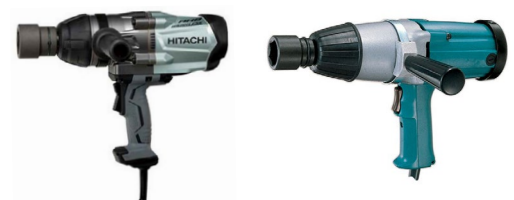
| Bar size | Brand | Model | Square drive | Weight | | Max Torque | Power Supply |
|---|---|---|---|---|---|---|---|
| 12 to 25 | Makita * | 6906 | ¾" | 12.3 | 5.6 | 588 | 110 - 240 V |
| 32 to 40 | Hitachi * | WR 25 SE | 1" | 16.9 | 7.7 | 1,000 | 110 - 240 V |

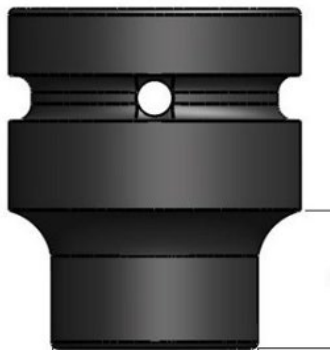
- A - Hexagonal socket dimension
- B - Square drive socket dimension
- C - Socket end max outside diameter
- D - Socket end min outside length
